Manhole Inspection Summary

Manhole # S53K__008MH

Insp Date: **4/9/08 3:13 PM**

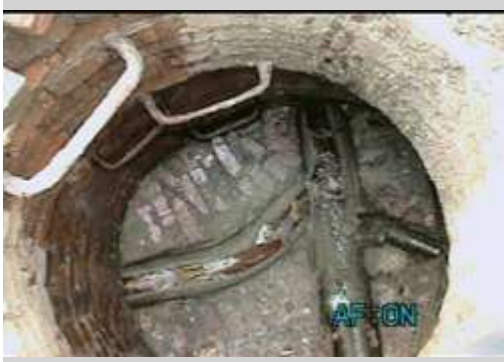
Defect 1

Steps Count: **4** Missing: **0** ☒ **Corroded**

steps corroded

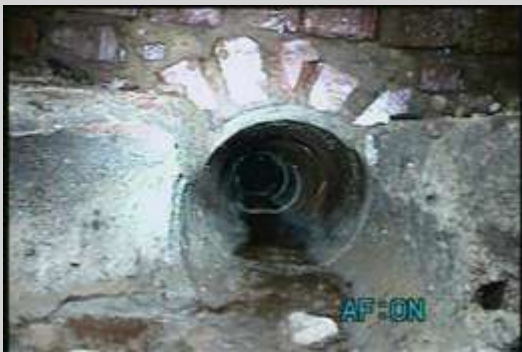
12 O'Clock Outflow

8 in. Circular Gravity Sewer
Pipe Out @ 12 O'Clock

Pipe Material: **Clay** ☐ Pipe Lined

Invert Depth: 7.20 (ft.) Flow Characteristics: **Fast**

Deposits: ☒ None ☐ Mud ☐ Sludge ☐ Debris ☐ Grease

Infiltration: **None** Pipe Seal Cond: **Unknown**

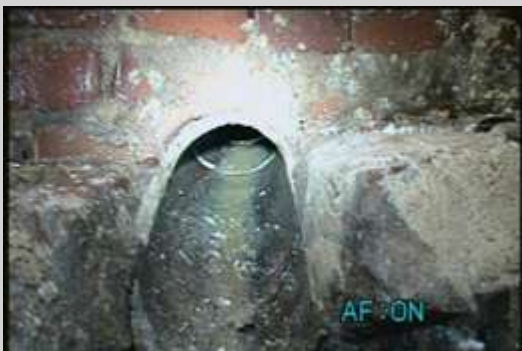
4 O'Clock Inflow

8 in. Circular Gravity Sewer
Pipe In @ 4 O'Clock

Pipe Material: **Clay** ☐ Pipe Lined

Invert Depth: 7.80 (ft.) Flow Characteristics: **Slow**

Deposits: ☒ None ☐ Mud ☐ Sludge ☐ Debris ☐ Grease

Infiltration: **None** Pipe Seal Cond: **Unknown**

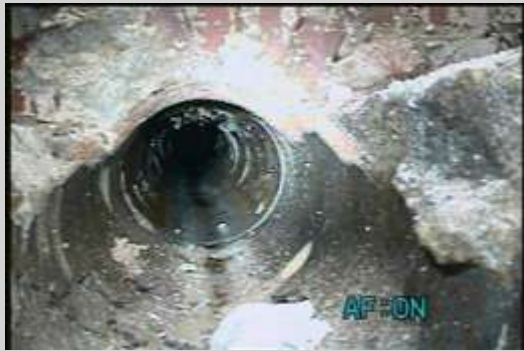
6 O'Clock Inflow

8 in. Circular Gravity Sewer

Pipe In @ 6 O'Clock

Pipe Material: **Clay** ☐ Pipe Lined

Invert Depth: **7.70** (ft.) Flow Characteristics: **Slow**

Deposits: ☒ None ☐ Mud ☐ Sludge ☐ Debris ☐ Grease

Infiltration: **None** Pipe Seal Cond: **Unknown**

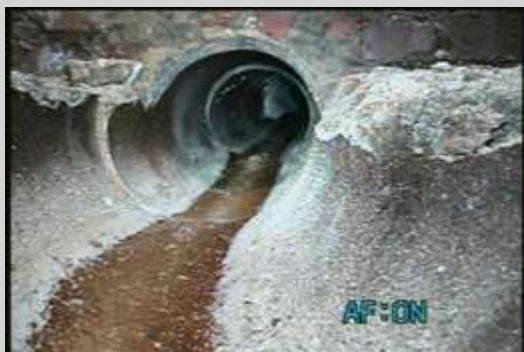
9 O'Clock Inflow

8 in. Circular Gravity Sewer

Pipe In @ 9 O'Clock

Pipe Material: **Clay** ☐ Pipe Lined

Invert Depth: **7.50** (ft.) Flow Characteristics: **Fast**

Deposits: ☒ None ☐ Mud ☐ Sludge ☐ Debris ☐ Grease

Infiltration: **None** Pipe Seal Cond: **Unknown**
